Navajo Abandoned Uranium Mine

Site Screen Report

Mine Name: Max Johnson No. 1
Mine ID: 125

August 2011

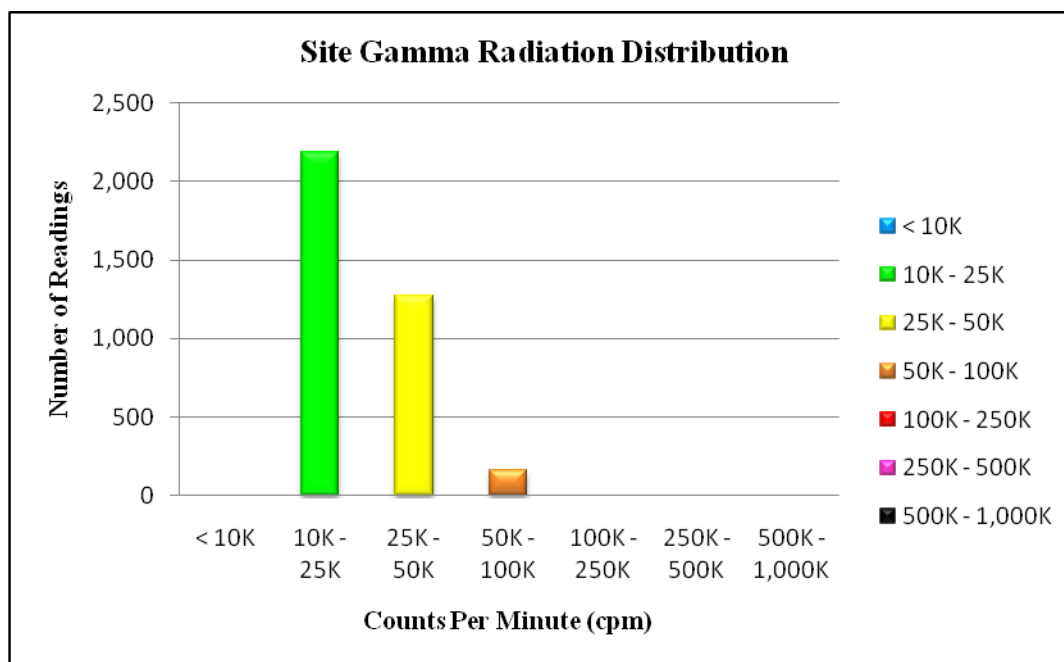
Distribution Chart and Statistics:

Site Gamma Radiation Statistics

Number of Readings	3,627
Minimum (cpm)	13,717
Maximum (cpm)	74,406
Mean (cpm)	26,226
Median (cpm)	23,004
Standard Deviation	10,377

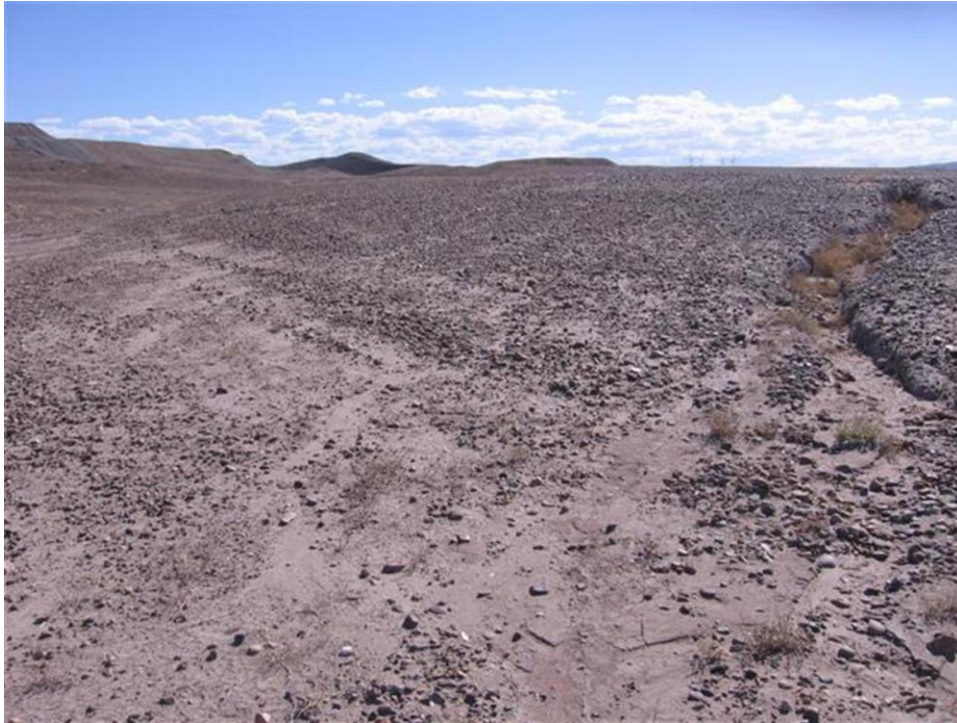
Photo 2: Mine Site #125; Reclamation area

Reclamation cap 1 (125ReclCap1): 550'x350'x6' oval, red-gray fine soil with rocks on top.

Reclamation cap 2 (125ReclCap2): 200'x600' rectangle, red-gray fine soil, mining debris (oil cans, wooden stakes, screws)

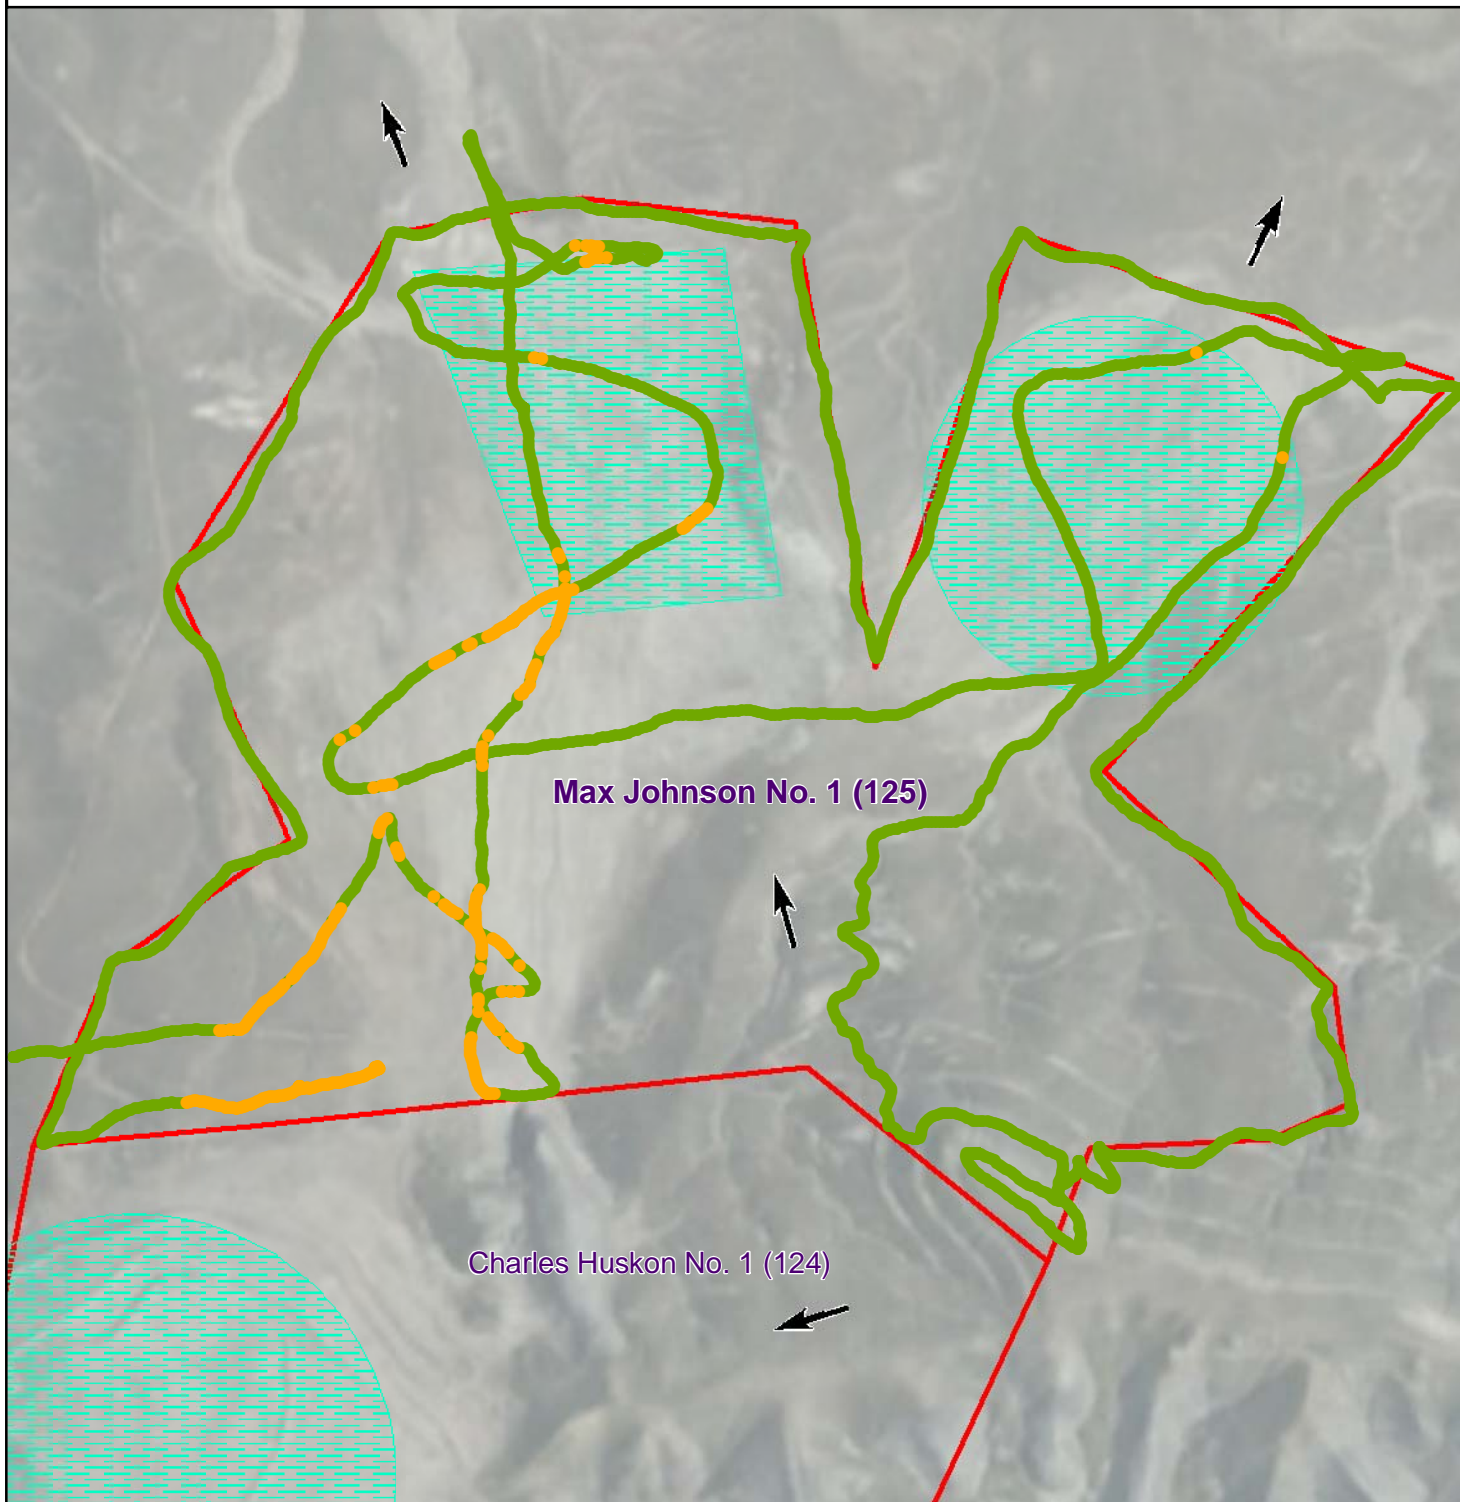
Figure 1 - Gamma Radiation Measurements, Above Two Times Background
Max Johnson No. 1 (125)
Coalmine Mesa Chapter, Navajo Nation

A total of 3,627 gamma radiation measurements were collected from the mine site, ranging from 13,717 cpm to 74,406 cpm. Measurements collected in the vicinity of the reclamation area were found at a maximum level of approximately 75,000 cpm. The measurements are represented in Figures 1 and 2.
